Monthly Progress Report for September 2022

October 14, 2022
File Number 21-13-0031D1

Subject: Monthly Progress Report for the Work Performed During the Month of September 2022, Related to the Approved Conceptual Closure Plan of the Piney Point Gypsum Stack System, Manatee County, Florida.

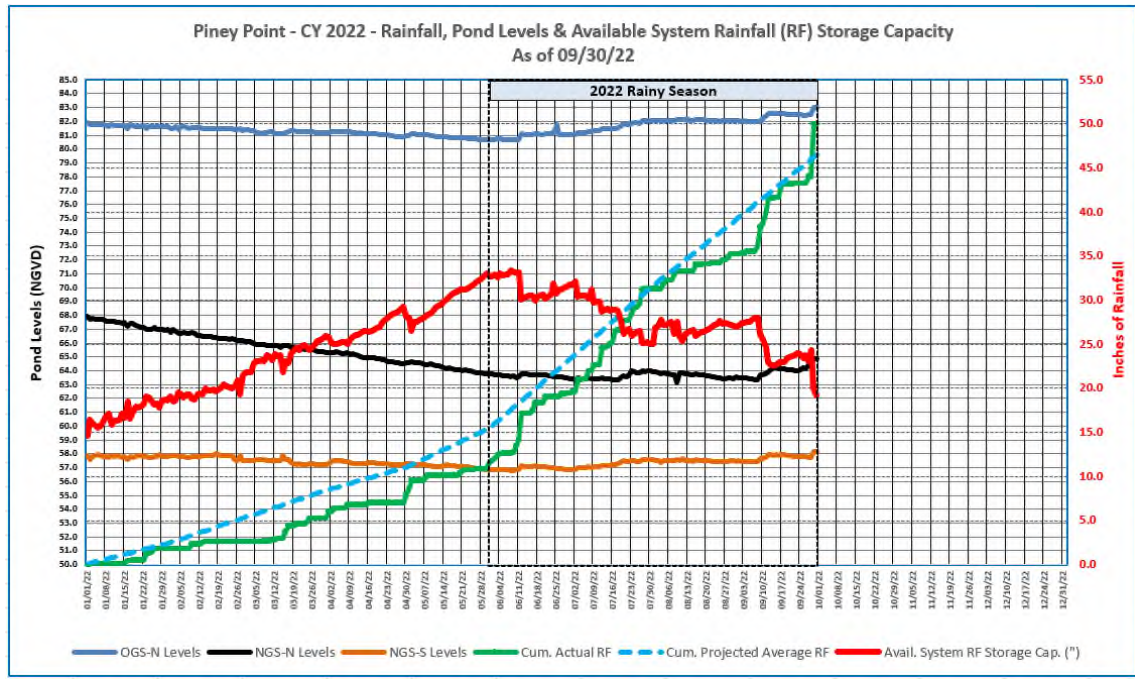
As of September 30, 2022 (end of the 2022 rainy season) the facility has received 50.0 inches of rainfall, which is 3.5 inches above the average rainfall of 46.5 inches for the same period.

The chart below shows year-to-date pond level readings, rainfall, and available system storage capacity.

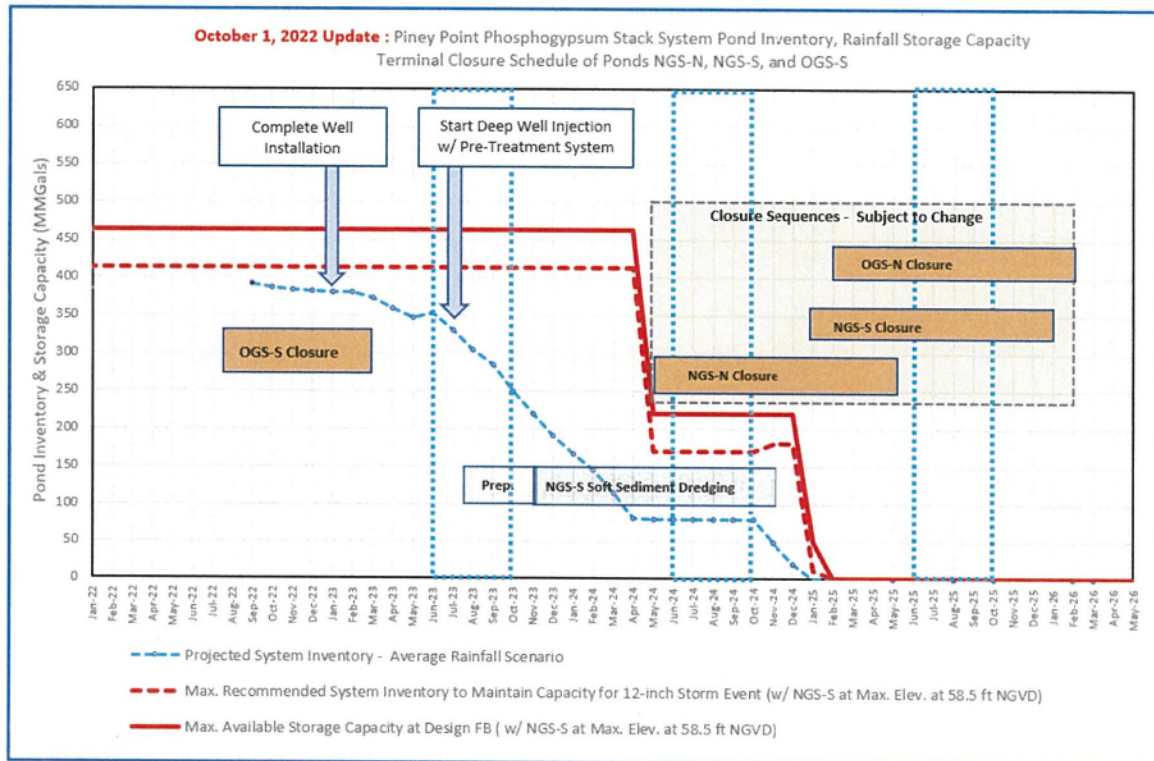
See below an updated version of “Figure 10 - Water Balance Projection and Anticipated Closure Timeline of the approved Conceptual Plan”.

The projected system inventory reflects measured pond level readings as of September 30, 2022 (end of 2022 rainy season).

Please note that the seepage rate has been adjusted to 130 GPM due to recent actual data for Structure #1.

Future closure dates reflect the new expected startup date (July 2023) of the pre-treatment system of the Deep Well Injection Project.

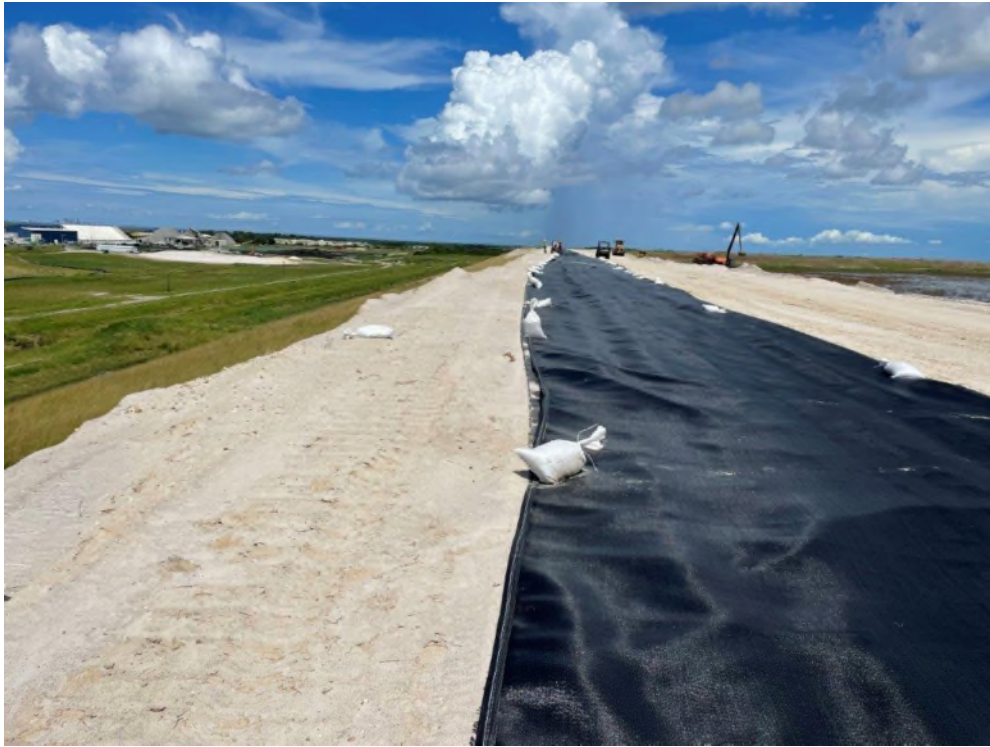
Photo 1 –Placing the Woven High-Strength Fabric

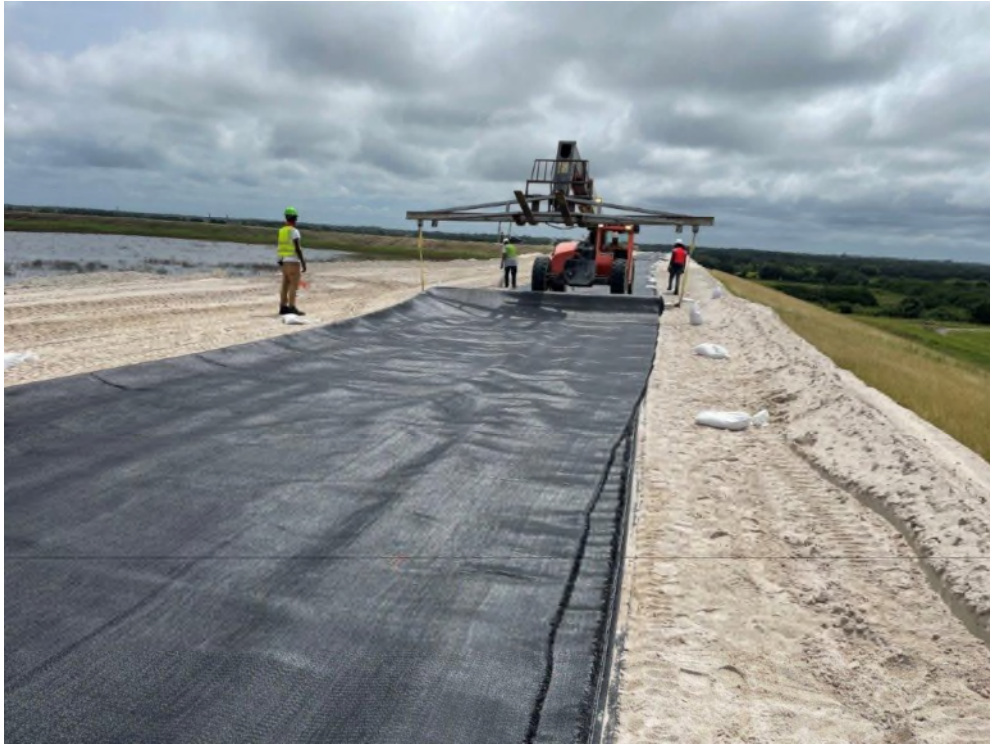
Photo 2 – Deploying the Woven High-Strength Fabric

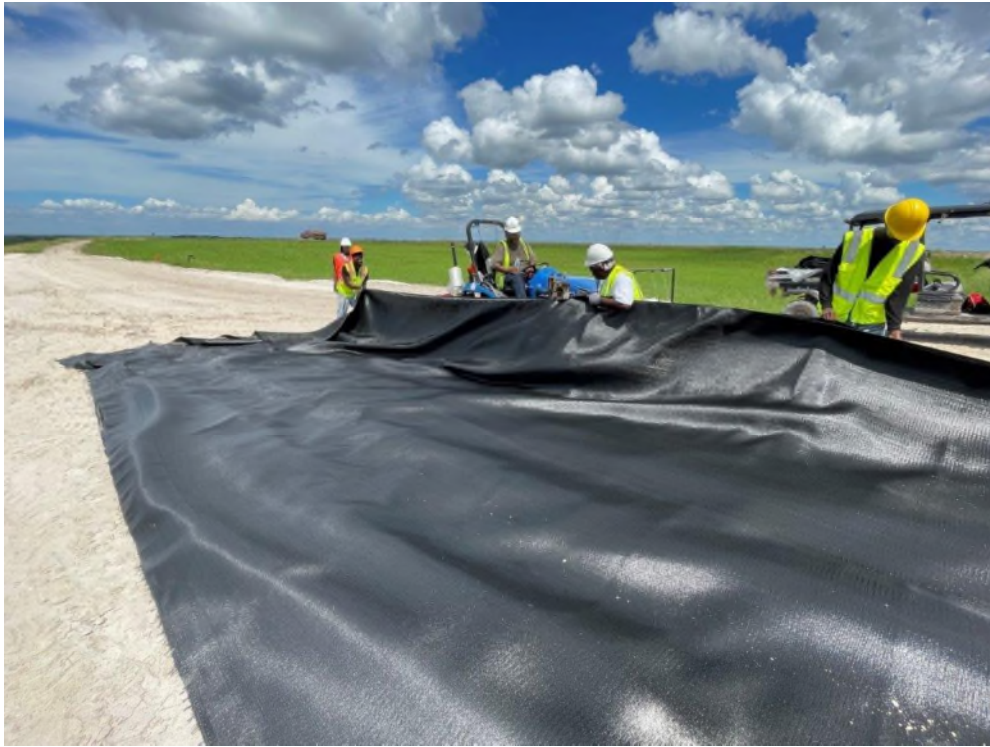
Photo 3 – Sewing the Woven High-Strength Fabric

Flint started sewing the woven high-strength fabric.

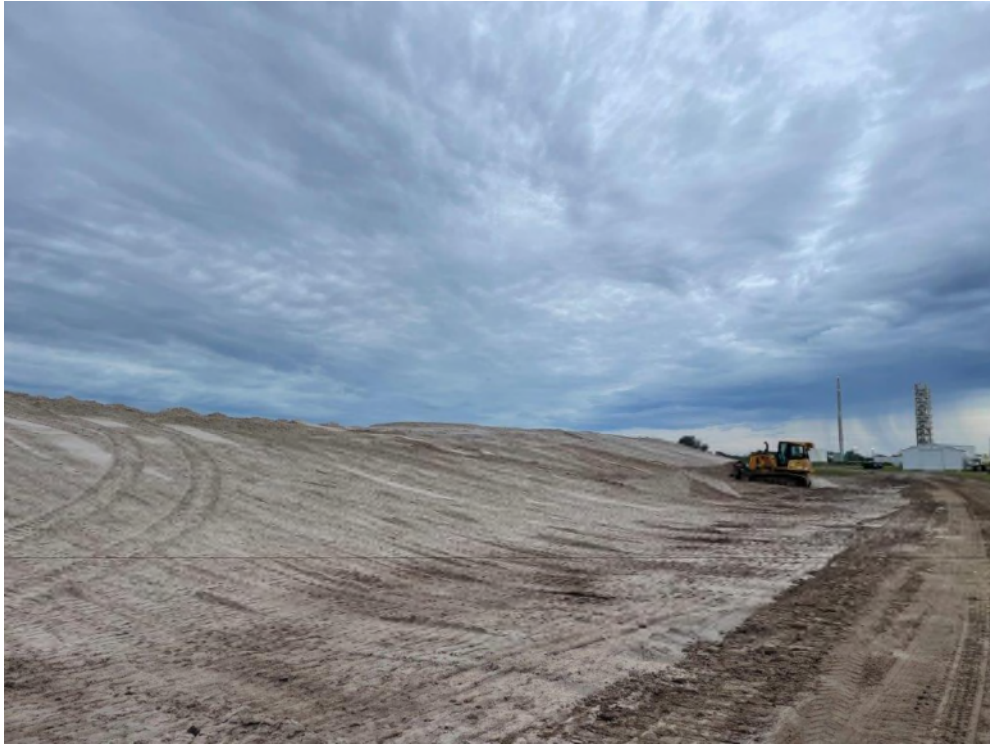
Photo 4 – Sand Tailings Stockpile

Sand Tailings: As of September 30, 2022, the Receivership has stockpiled 79,686 cubic yards of sand tailings on site (64,872 yards from Ft. Green and 14,814 yards from Ft. Meade Sand Mountain). Due to shortage of sand tailings within the limits of the approved borrow area at the Ft. Green Sand Pit, Mosaic agreed to the expansion of the borrow area to the immediate north. A wildlife survey of the expansion area was completed on September 13, 2022. Following the relocation of a gopher tortoise that took place on September 20, 2022, Mosaic gave final approval for DRS to begin expanding the sand borrow area. DRS will continue hauling sand tailings from Ft. Green.

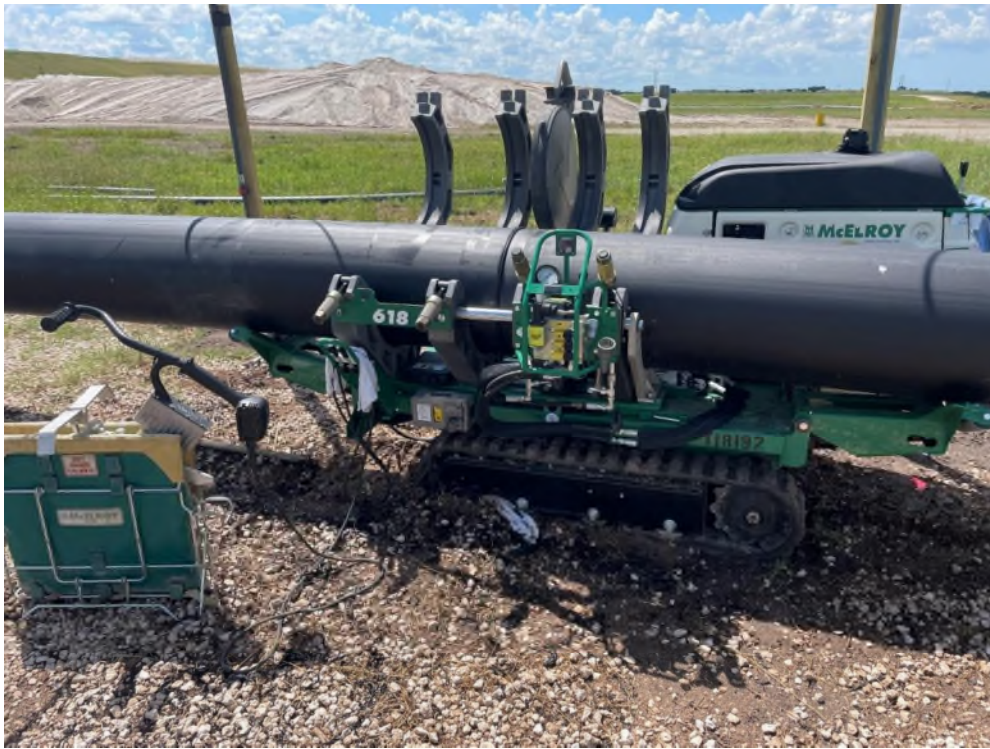
Photo 5 – Welding the 18-inch HDPE pipes

Continued welding the 6-inch and the 18-inch HDPE pipes.

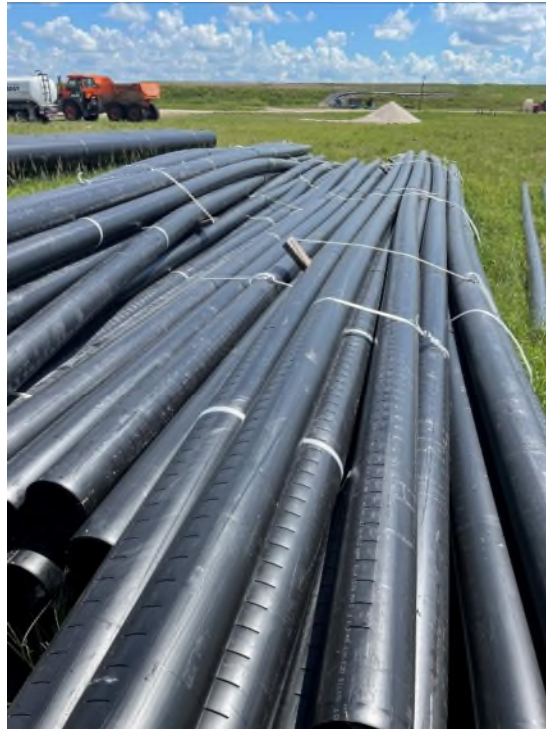
Photo 6 – Welding the Slotted 6-inch HDPE Pipes

Continued welding the slotted 6-inch HDPE pipes.

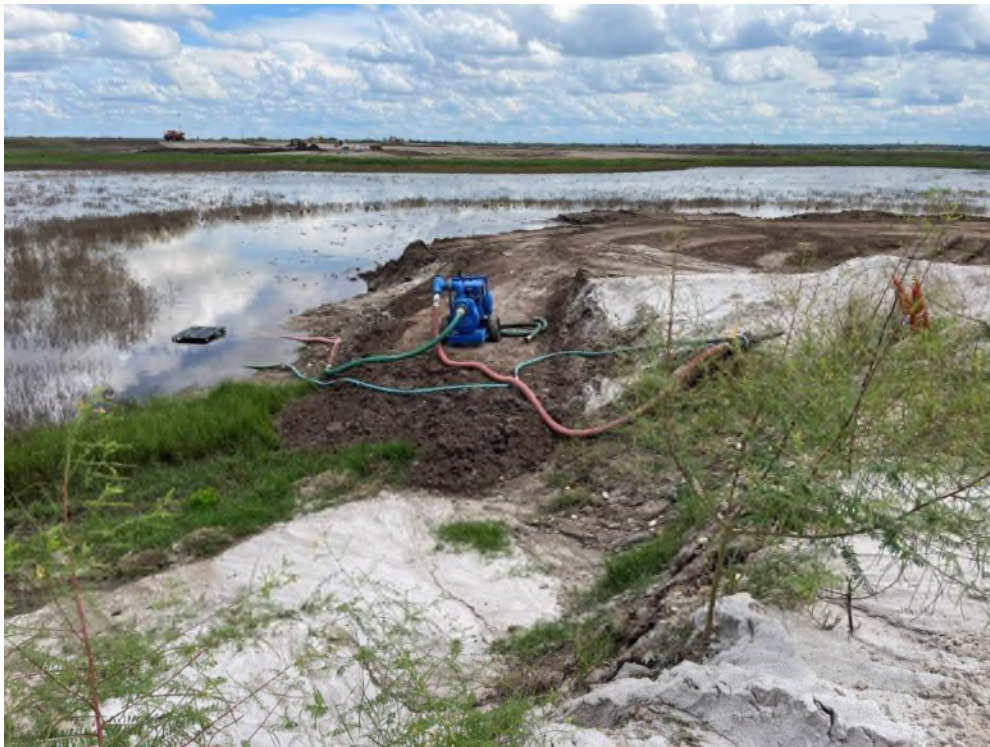
Photo 7 – Dewatering Pump - Sump Area

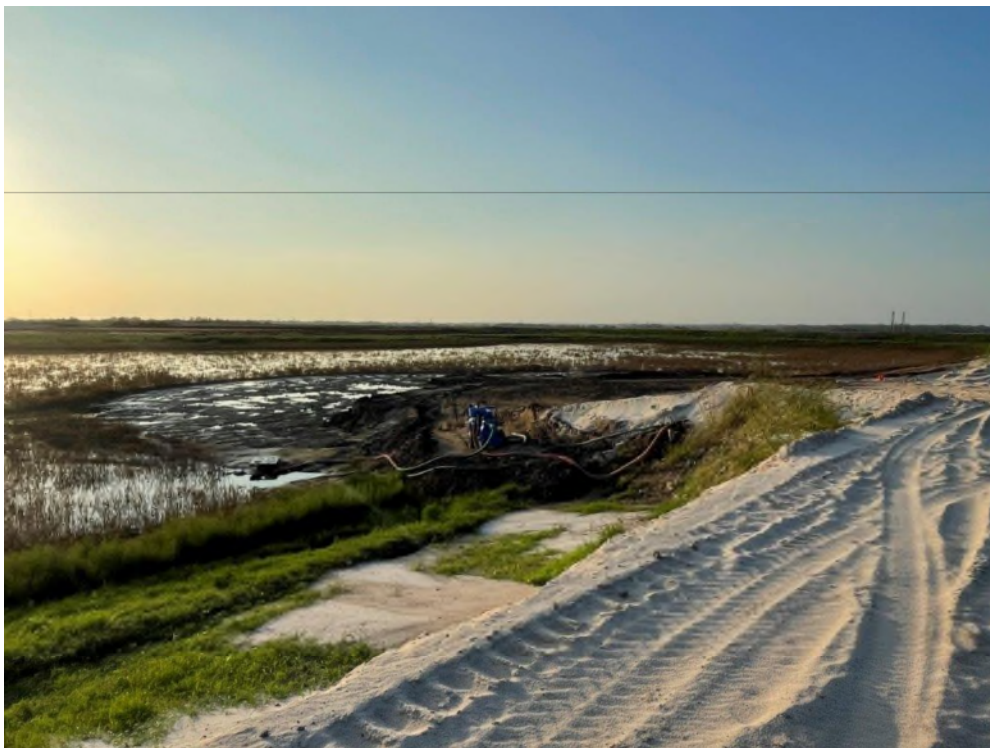
Photo 8 – Dewatering Pump - Sump Area

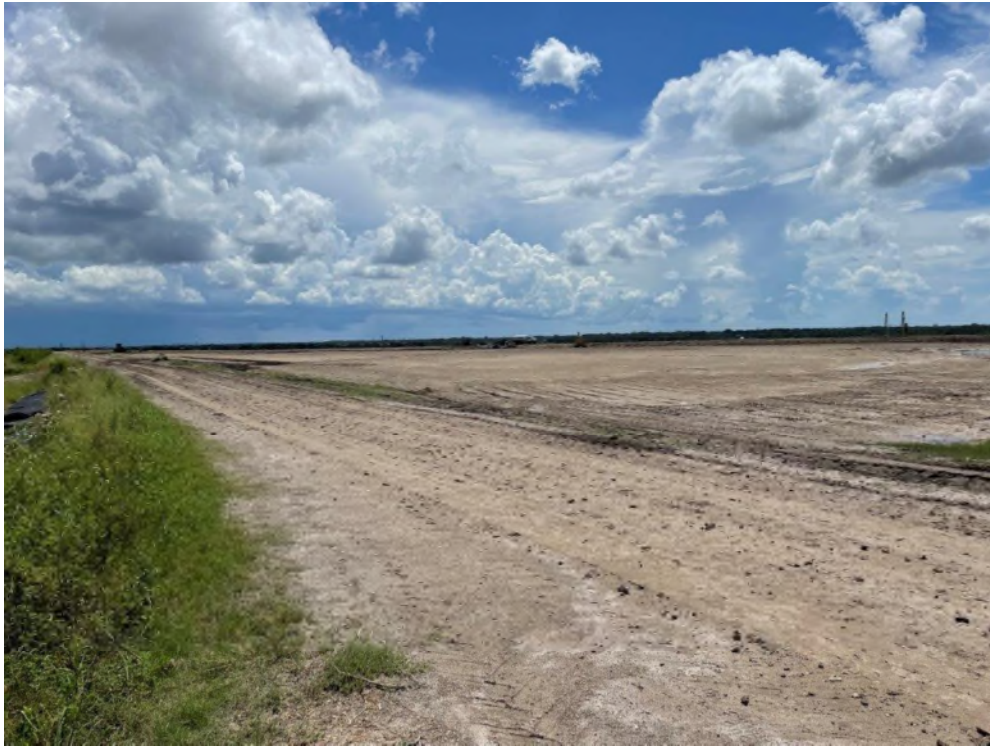
Photo 9 – Grading Coarse Dredge Material on the East Side of OGS-S Pond

Continued working on hauling, placing, and compacting fill material over the coarse sediments area to establish positive drainage.

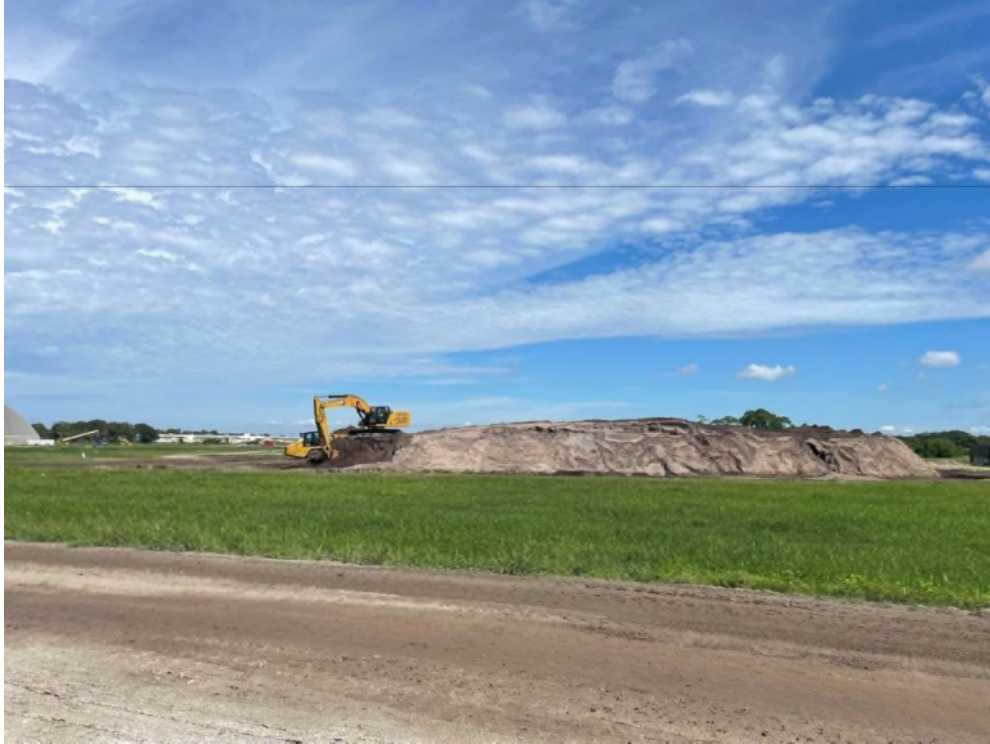
Photo 10 – Hauling Soil from the Stockpile to Place 1-foot Thick Layer of Soil

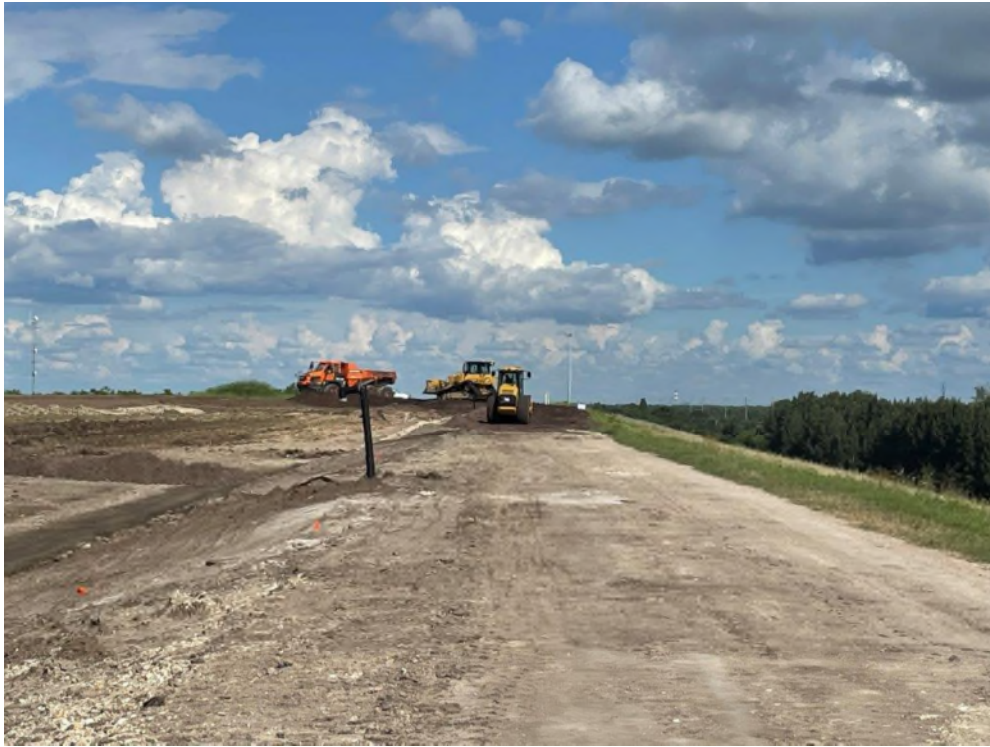
Photo 11 – Placement and Compaction of a 1-foot Thick Layer of Soil

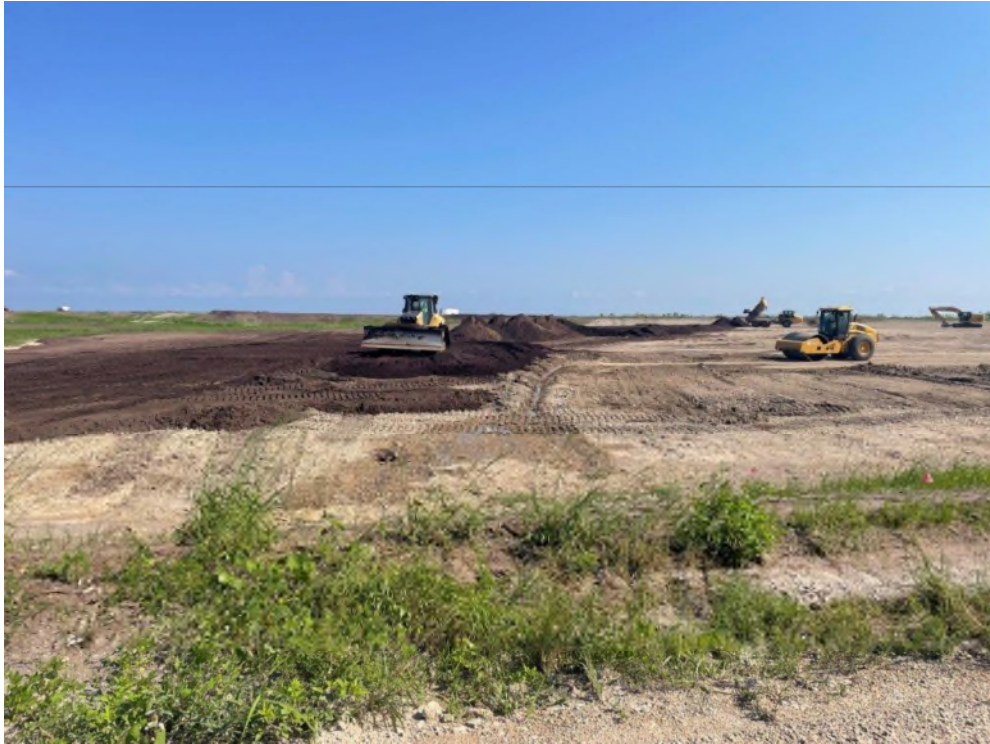
Photo 12 – Placement and Compaction of a 1-foot Thick Layer of Soil

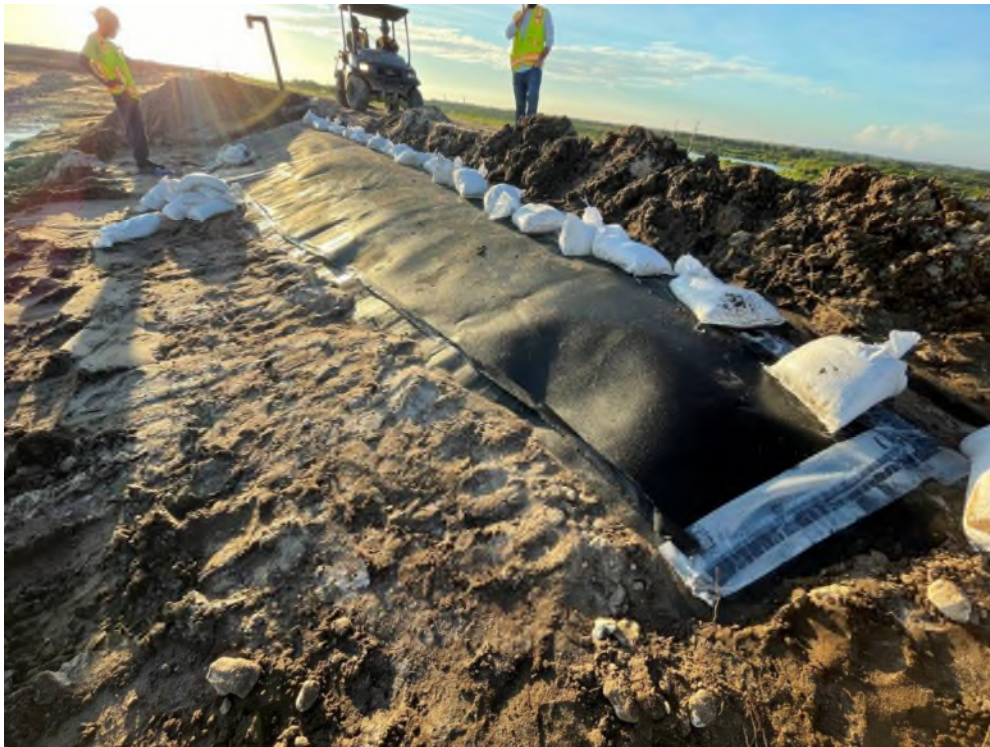
Incident report: Property Damage – September 7, 2022 – A Forgen equipment operator was grading the rim of the southeast corner of the OGS-S pond with a Caterpillar D5 dozer, and made contact with and tore a section of the old primary liner. The size of the tear was approximately 33 feet by 4 feet.

Photo 13 – Temporary Repair of the Primary Liner Tear

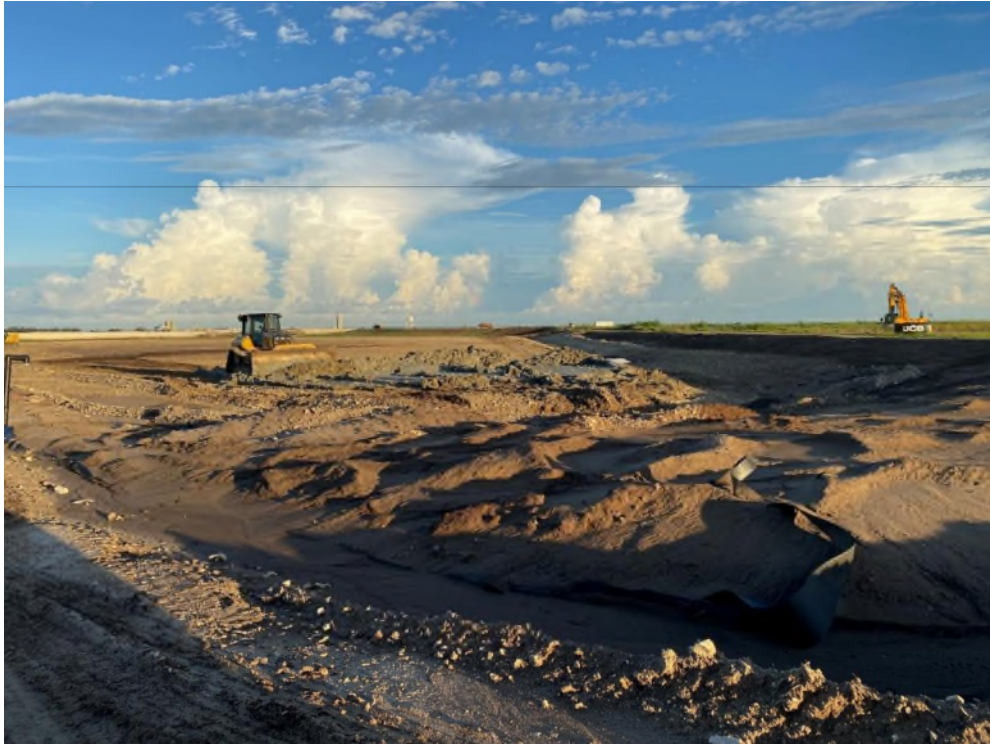
Completed exposing the old sacrificial liner along the southeastern and northeastern sections.

Photo 14 – Completed Exposing the Old Secondary Liner on the East Dike

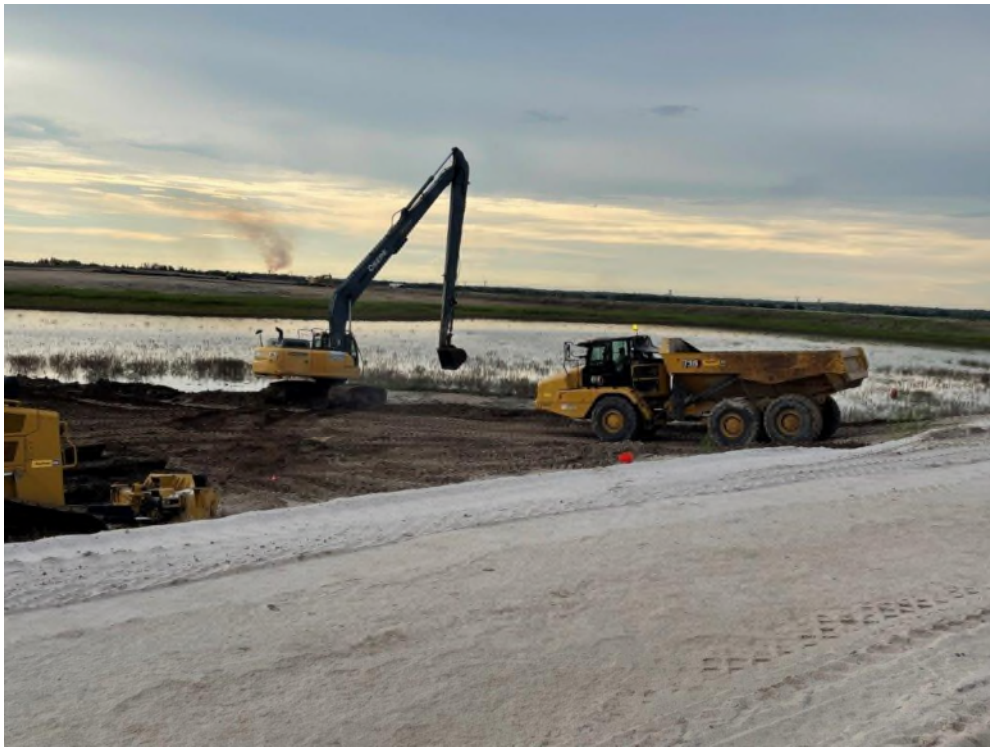
Backfilled the sump area after cleaning and draining the water.

Photo 15 – Excavating and Grading the Sump Area

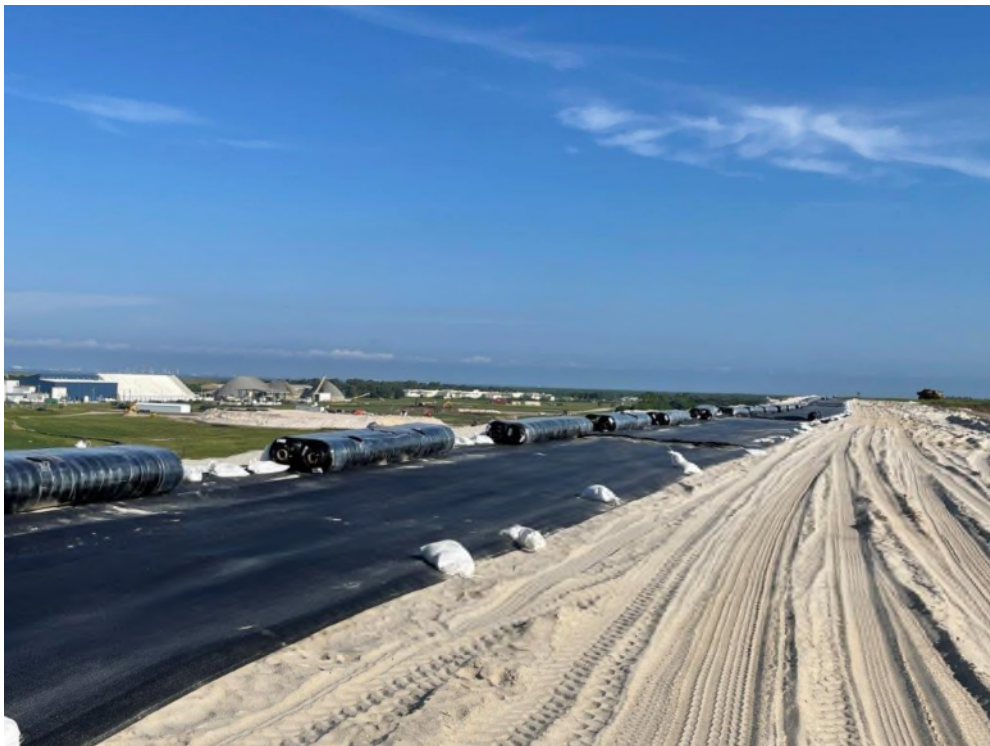
Prepared the site for Hurricane Ian and either secured in place any material and equipment that could be blown away by strong winds or stored them in a safer location.

Photo 16 - Site Preparation for Hurricane Ian
