PINEY POINT – A TALE OF TWO CLOSURES

MOHAMAD AL-HAWAREE, P.E. & PHONG VO, OF ARDAMAN & ASSOCIATES INC.,
AND HERBERT R. DONICA, OF DONICA RECEIVERSHIP SERVICES, LLC

JUNE 15TH, 2022

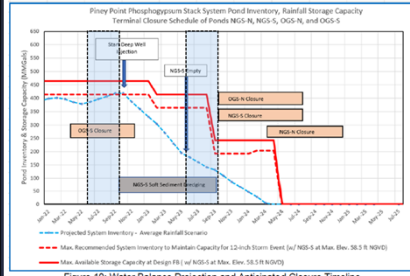
Piney Point Gypsum Stack - System Pond Inventory Projection

(Structure 1 Seepage Rate @ 128.4 GPM & DWI Op. on 11/1/22)

Figure 10: Water Balance Projection and Anticipated Closure Timeline

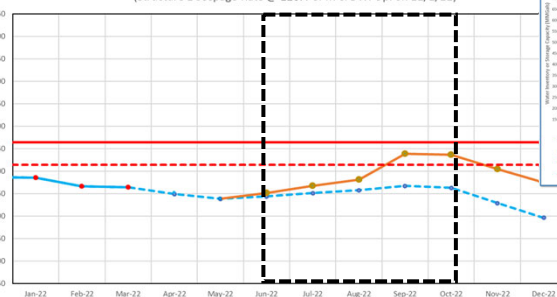
IMPACTS of Watershed
4.2 MG/Day, 18.5 MG @ 11 MG/Day

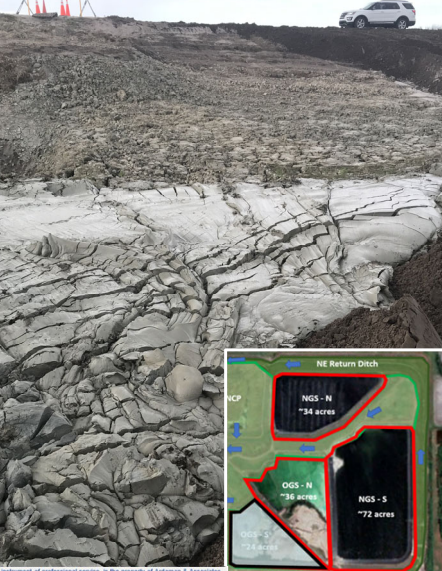
Figure 7. Thickness of the soft mud. Aerial photo was obtained from FDOT, 1 m = 3.28 ft.
