## 35th Annual Regional Mining Conference

# ***PINEY POINT – A TALE OF TWO CLOSURES***

**MOHAMAD AL-HAWAREE, P.E. & PHONG VO, OF ARDAMAN & ASSOCIATES INC.,  
AND HERBERT R. DONICA, OF DONICA RECEIVERSHIP SERVICES, LLC**

**OCTOBER 12, 2022**

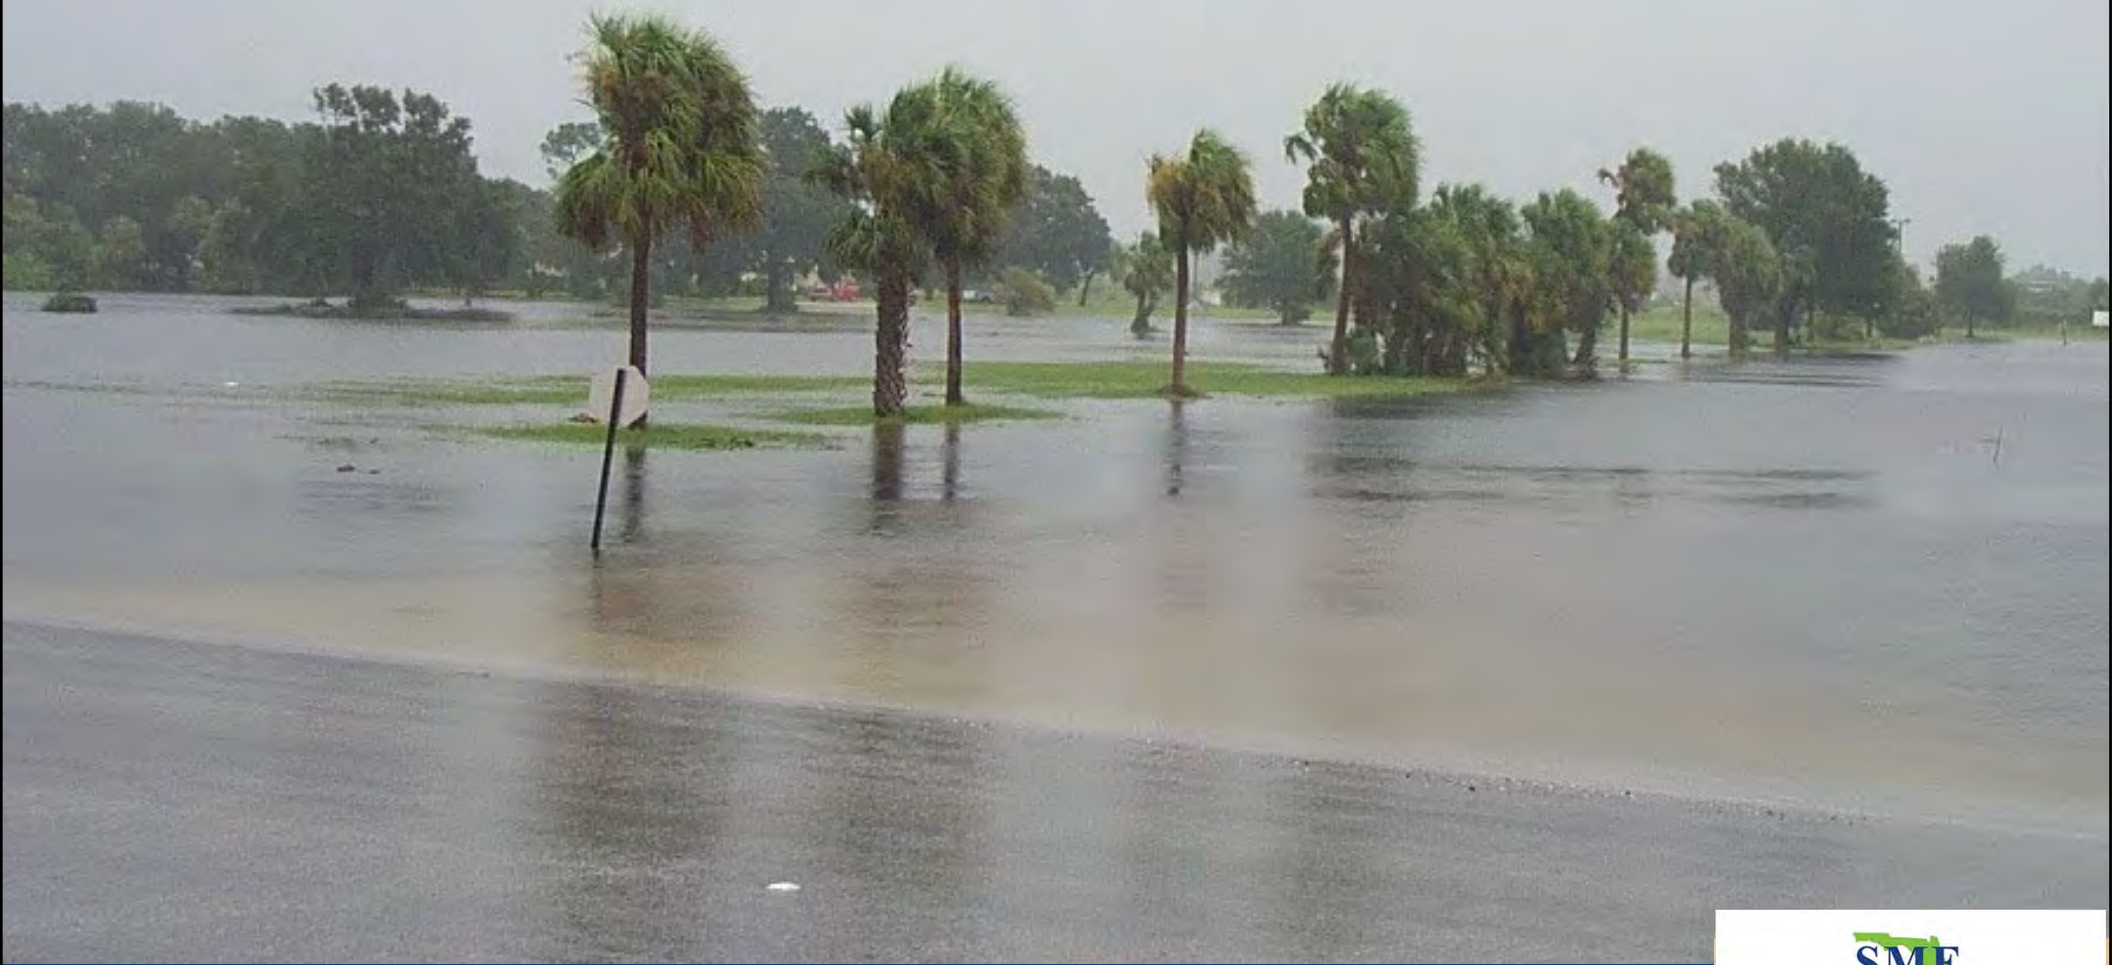
**DECEMBER 2002**

**16.5 inches of rain = 500-year event**

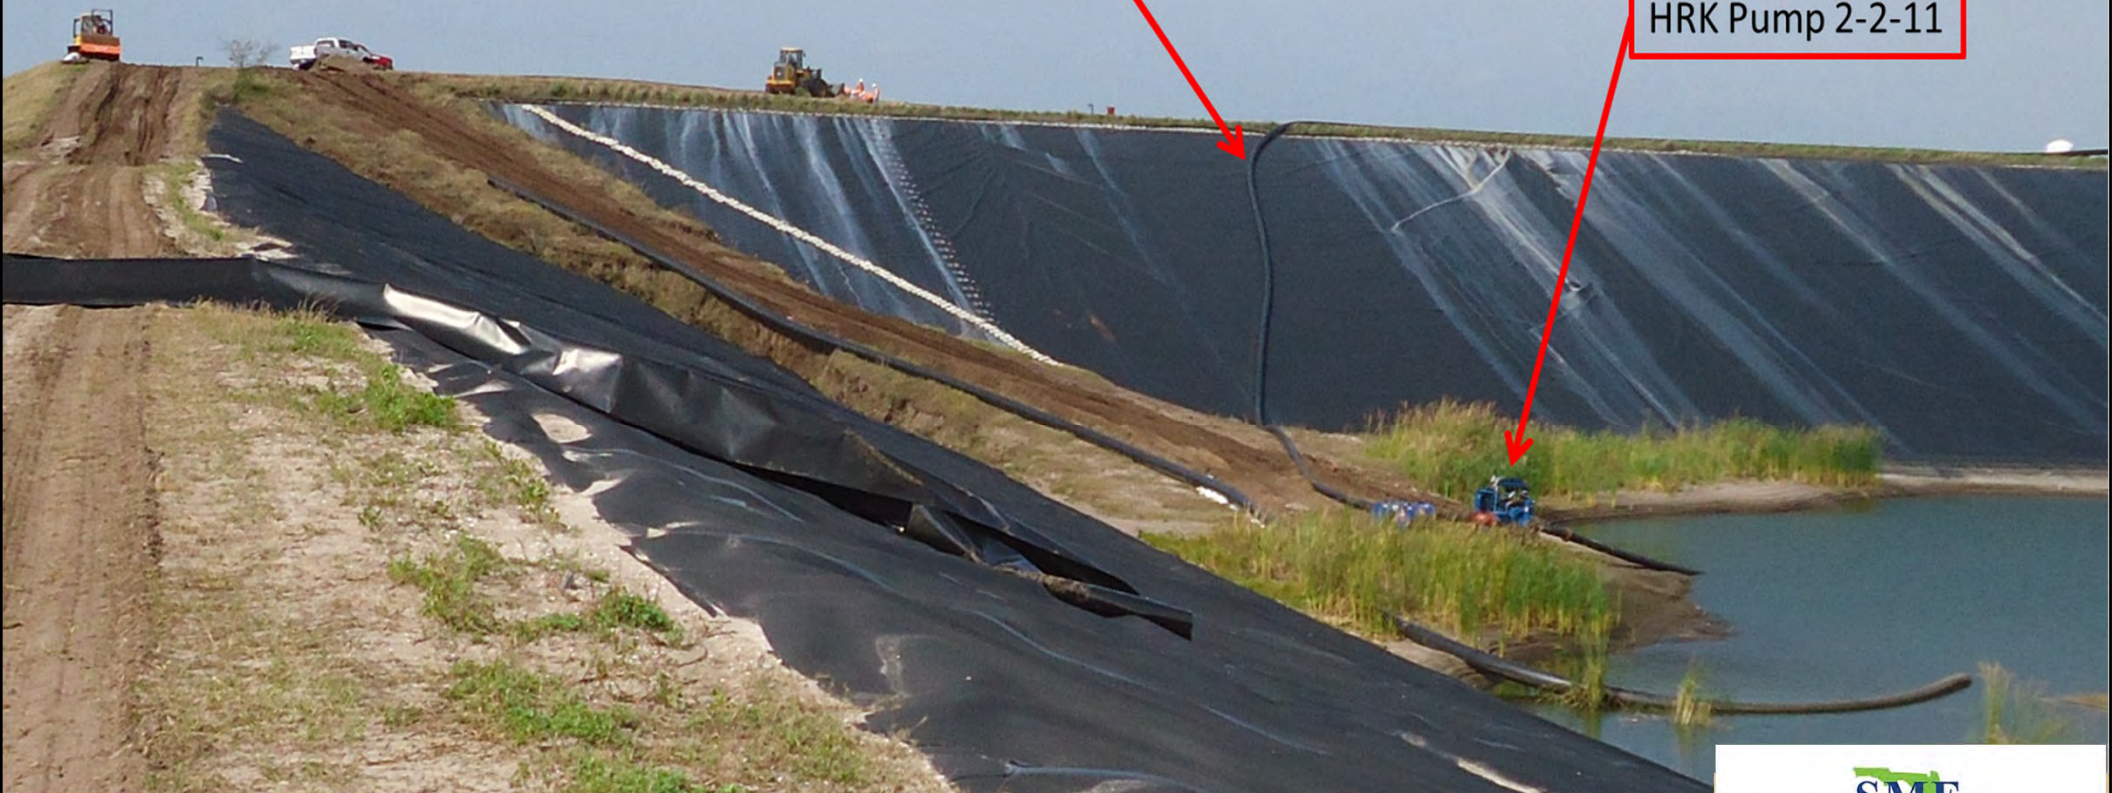
Pump Discharge Line

HRK Pump 2-2-11

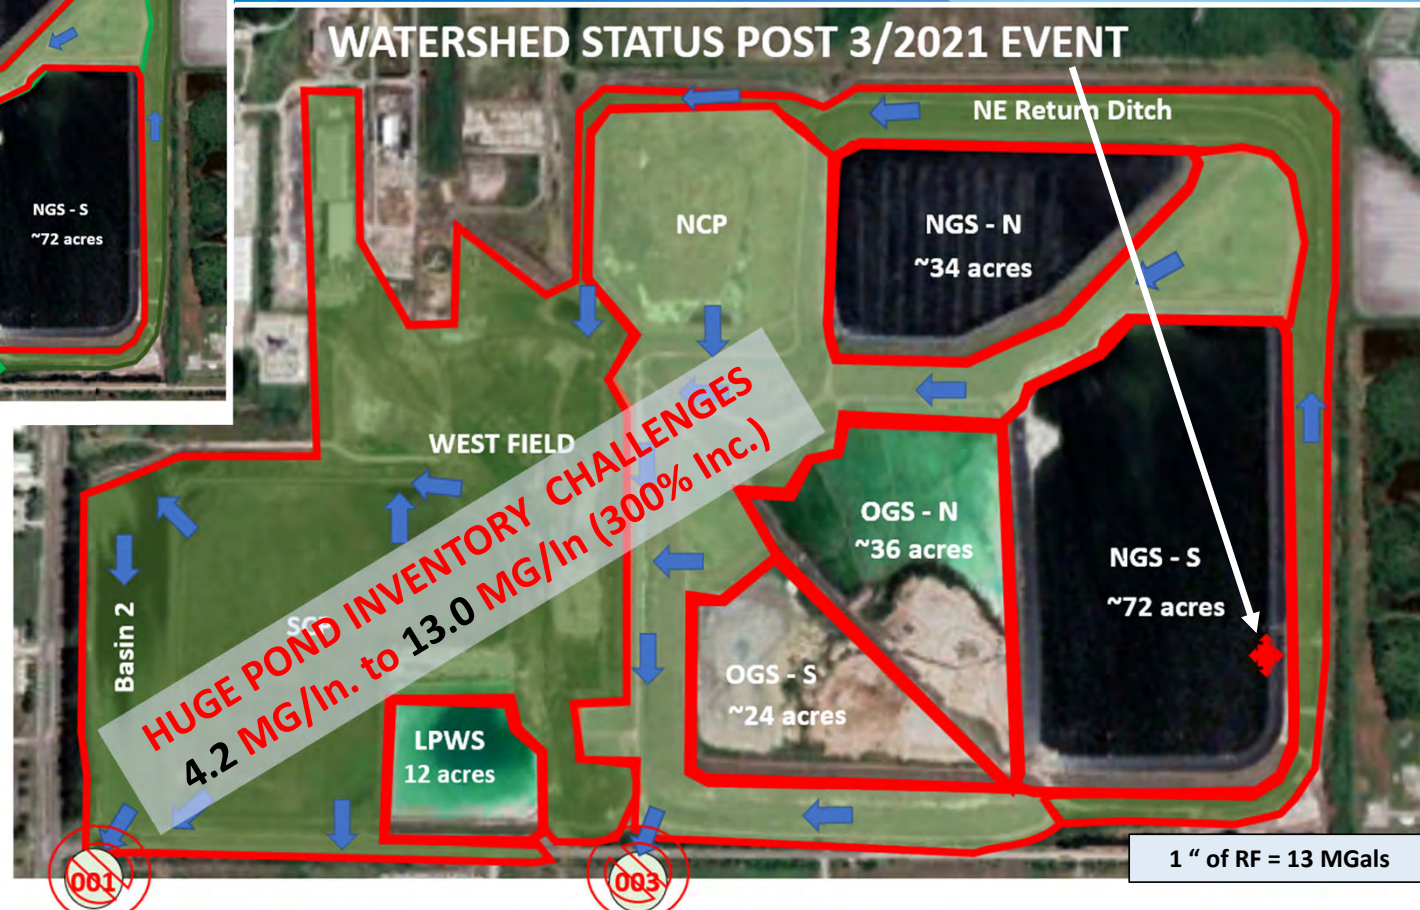
WATERSHED STATUS POST 3/2021 EVENT

Total watershed footprint: 478 acres

- 300 acres (previously closed)
- 178 ac. of ponds to be closed

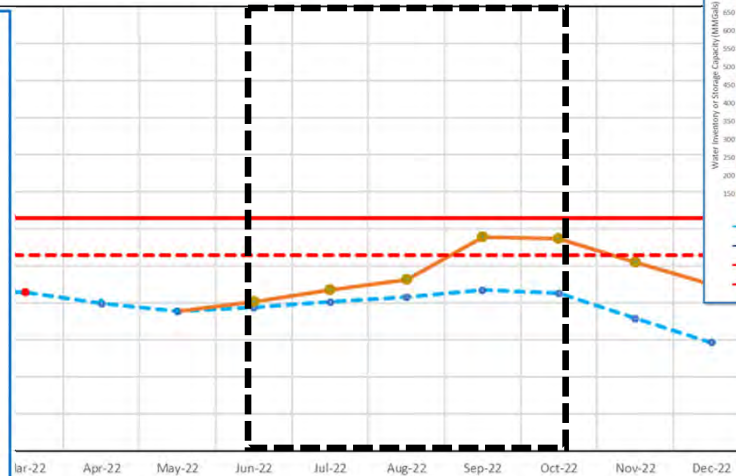
Piney Point Gypsum Stack - System Pond Inventory Projection  
(Structure 1 Seepage Rate @ 128.4 GPM & DWI Op. on 11/1/22)

09/01/2022 Update : Piney Point Phosphogypsum Stack System Pond Inventory, Rainfall Storage Capacity  
Terminal Closure Schedule of Ponds NGS-N, NGS-S, and OGS-S
