**NOTICE OF FILING RECEIVER'S  
MONTHLY PROGRESS REPORT FOR OCTOBER 2022**

**Monthly Progress Report for October 2022**

Subject: Monthly Progress Report for the Work Performed During the Month of October 2022,  
Related to the Approved Conceptual Closure Plan of the Piney Point Gypsum Stack  
System, Manatee County, Florida.

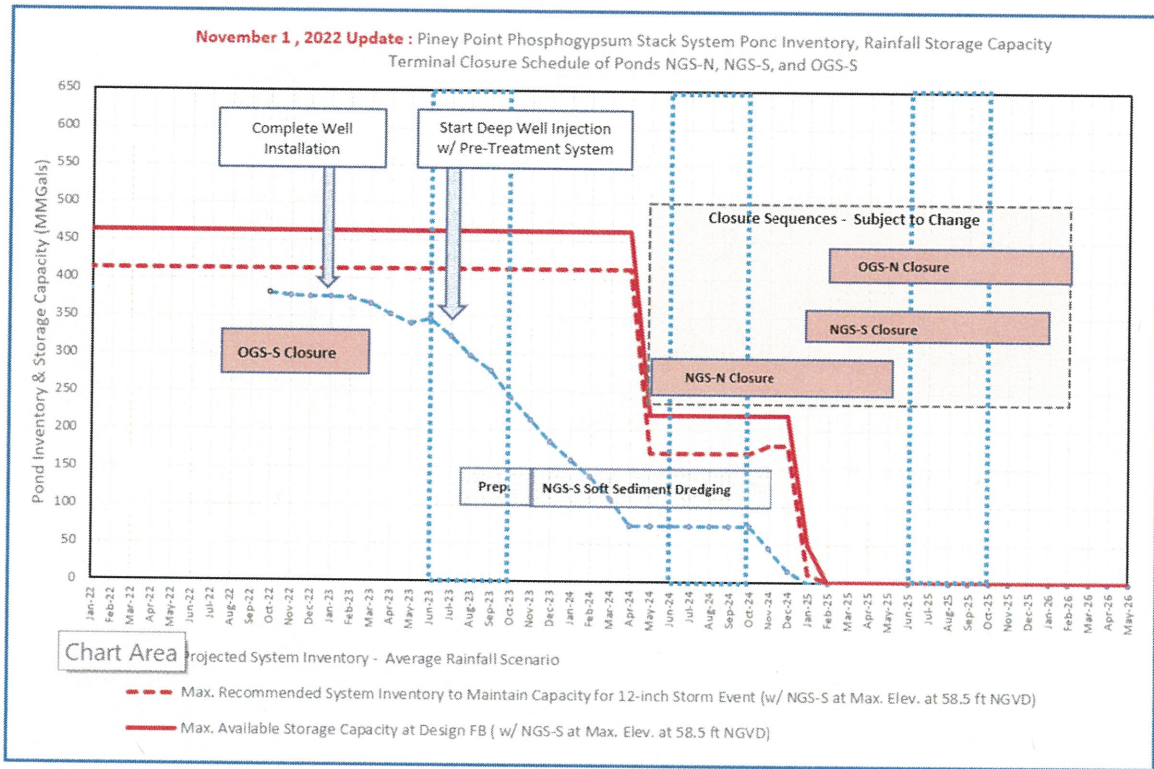
- See below an updated version of “Figure 10 - Water Balance Projection and Anticipated Closure Timeline of the approved Conceptual Plan”.
- The projected system inventory reflects measured pond level readings as of October 31, 2022.
- Please note that the seepage rate has been adjusted to 130 GPM due to recent actual data for Structure #1.
- Future closure dates reflect the new expected startup date (July 2023) of the pre-treatment system of the Deep Well Injection Project.
